**Re: Reconnaissance Inspection
Guánica Wastewater Treatment Plant
NPDES Permit Number PR0020486**

Summary of Findings/Comments
Water Compliance Inspection Report Form
(EPA Form 3560-3)

RECONNAISSANCE INSPECTION

Facility Name: Guánica WWTP
NPDES Permit Number: PR0020486
PRASA Representative: Amalio Quirós, Plant Operator

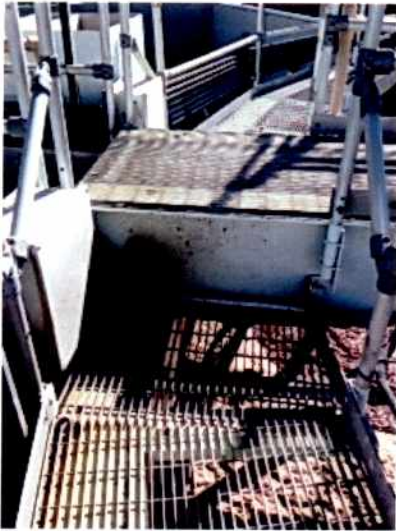
Guanica WWTP (RI)
December 21, 2015
Figure # 1 – BNR.

- 1) The BNR bridge has no step at the lower level to safely reach the upper level (and vice versa), as shown in Figure # 1 attached.
- 2) Scum, grease and excessive froth were observed at the surface of the digester, as seen in Figure # 2 attached.

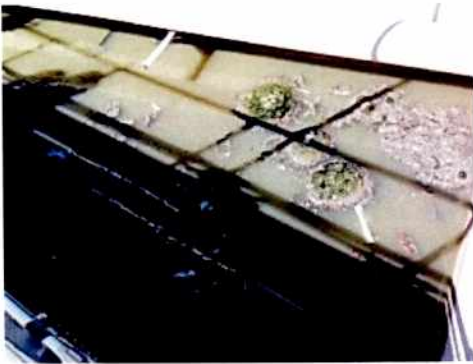
Guanica WWTP (RI)
December 21, 2015
Figure # 3 – Anoxic Stage 1.

- 3) Old sludge, grease, and algae growth was observed at the anoxic stage # 1, as seen in Figure # 3 attached.
- 4) Solids and grease were observed at the anaerobic stage # 1, as seen in Figure # 4 attached.

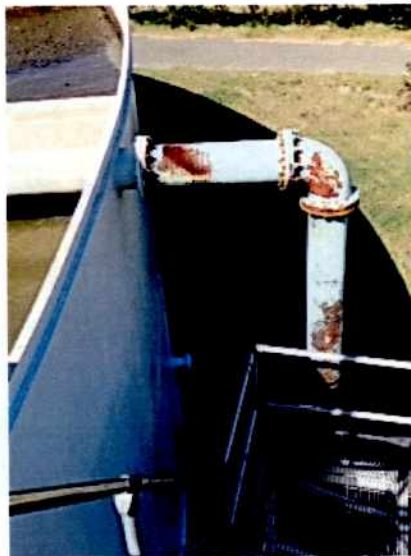
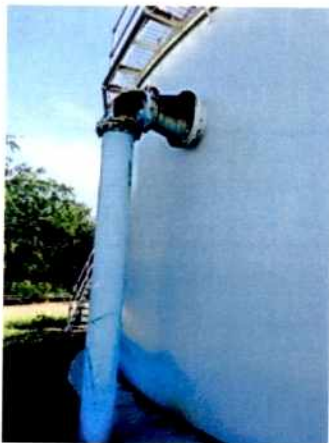
- 5) Evidence of corrosion were observed at different units at the plant, as seen in Figures # 5 and # 6 attached.
- 6) According to the operator, there was no control of the recirculation pumps, floccules were being lifted. Variators were not properly working. For effectiveness in the process, variators were being operated manually.

Guanica WWTP (RI)
December 21, 2015
Figure # 5 – Corrosion.

Guanica WWTP (RI)
December 21, 2015
Figure # 6 – Corrosion.
